MEASURING AND MONITORING SYSTEMS ELECTRICAL AND MECHANICAL PARAMETERS FOR VIBRATION IN RUNNING TRAMS

ing. KAJTOR V.
Oradea Transport Local S.A.

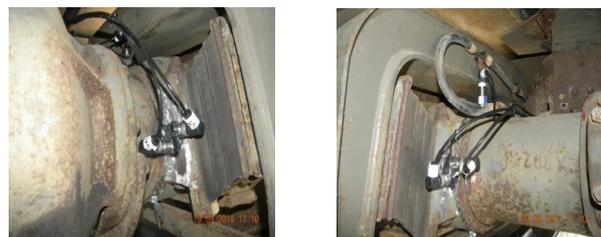
- Vibration sensor mounted on three axes (vertical, axial and on travel direction) in axle No. 3.

Fig.2. Vibration sensor mounted

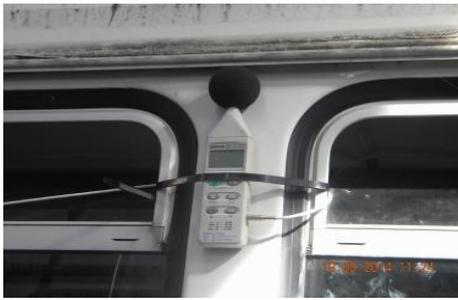
Fig.3. Sound level meter mounted on the outside

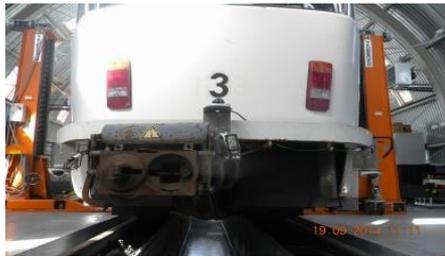
Fig.4 Cameras at each track and one in the middle for location controlled area.

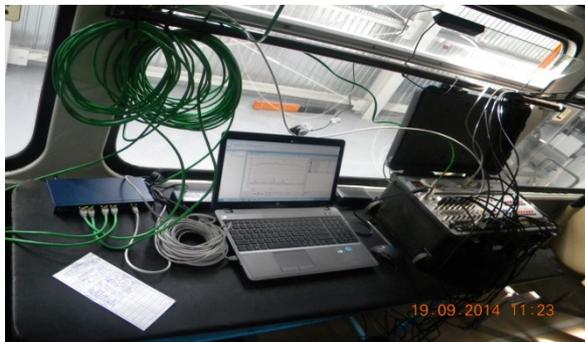
For recording and data processing a signal amplifier type has been used, with 8 channels, one splitter for coupling cameras and a GPS connected to the acquisition board. Vibration registration is given concomitantly with GPS position of cameras and level meter recording.

Fig.6. Signal amplifier

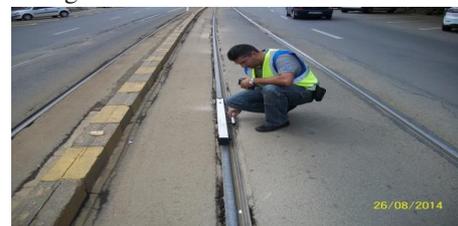
Wave measurements on both wear -lane were obtained average values of 0.6-0.7mm.

Fig.9. Wave measuring and the chart wear

In the figure above, for a length of 1 m difference between maximum and minimum is 0.67mm.
