TRAMWAY SYSTEM VULNERABILITIES CAUSED BY STORM. CASE STUDY: LIGHTNING IN ORADEA, 10-TH JUNE 2013

ABSTRACT: Short history, theoretical presentation, risk analysis of damage probability of extreme weather effects, lightning and storm, technical and economic aspects, recommendation for public transport operators. Case study: example of a lightning damage effects in Oradea.

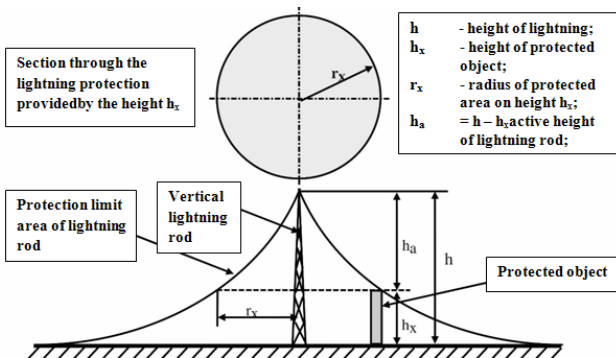
where the r_x , h_a , h_x are in meters, noted in Fig. 4:

Fig. 4 - A simplified representation of Franklin rod lightning protector and the protected area

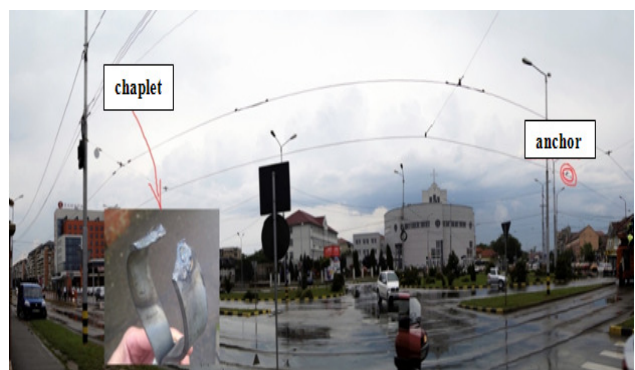
cost of a full protection will be argued by the economic efficiency of the total cost of operation. A meteorological phenomenon took place in 2013, the June 10-th, in the early afternoon thunderstorms truck by lightning more Oradea, whose impact was the loss of Tramway services. The lightning touched sector was energy powered by the "Zamfirescu" street rectifier, the impact was at the pillar number 770 (Decebal-Aradului street crossing section), the effects of lightning was recorded by a datalogger. In a very short time, the maintenance team quickly solved the incident (poweroff, cable repair, reboot and restart).

Fig. 5 - The location of the reported incident on June 10-th, 2013 and its impact

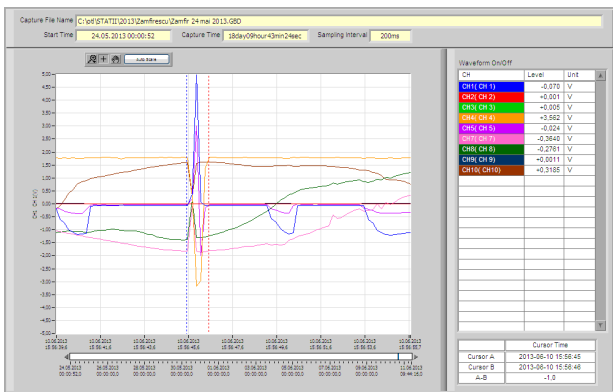
Fig. 7 - The "Big Moment": June 10-th, 2013 at 15h 56m 45s, lightning discharge voltage and current diagrams

The Fig.6 show at 15h 56m 45 seconds at a peak observed phenomenon, which clarifies the translation impact of the lightning current flow in Fig.7. The electrical discharge is about half a second period recorded by the device, which looks like the diodes dissipate the discharge current. In the Ch4-U_{CC}, the power supply (orange) and Ch1-I_{tot}, the supply current (blue), both forms give the most. During the event, the discharge may be damaged the electrical insulation, so it is essential that these items to be immediately after the event (or in short time!) verified and cleaned/repaired/changed.

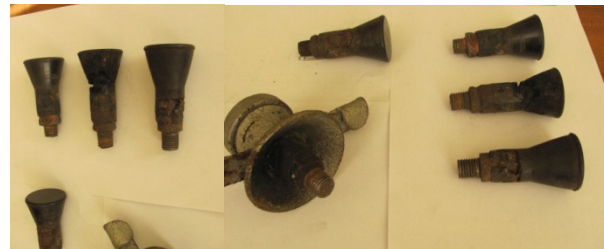
Fig. 8 - Samples of exchanged anchors and insulators

As we can see, the insulation values of cables show the value of damage. In lucky case remains a few tens of Mega-Ohm, not the same can be said with a very damaged insulation values, which have declined under value of Kilo-Ohm, the contact wires system requiring immediate maintenance. The line wire insulation may be damaged by "drag & drop" effects of discharges, the insulation value maybe re-store with a serious wash of insulators with acetone or other isopropyl alcohol, if need it is essential the elimination of the losses spare parts. During the repair, after related events we find to "Zamfirescu" ST2 sector 3 pcs of anchors must be replaced. The power station "Zamfirescu"-ST2 values are repaired from 10kΩ to 199,2MΩ after intervention, it's a best practice of a proper maintenance after unexpected events.
