# ASSESSING THE COSTS OF THE THERMAL REHABILITATIONS OF A STUDIO BLOCK ENVELOPE

DINU, R.C., POPESCU D., STAN-IVAN F.E.

University of Craiova, Faculty of Electrical Engineering, Decebal no.105, Craiova

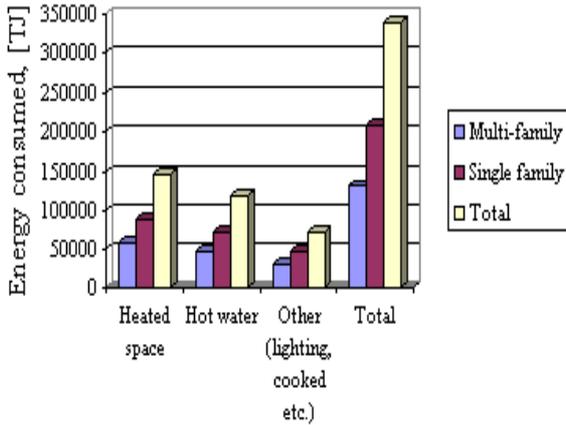
**Fig. 1 - Energy consumption by type of housing in 2010 [10]**

In 2010, energy consumption in the domestic sector are presented, by fuel types (Table 1) and by type of housing (Figure 1).

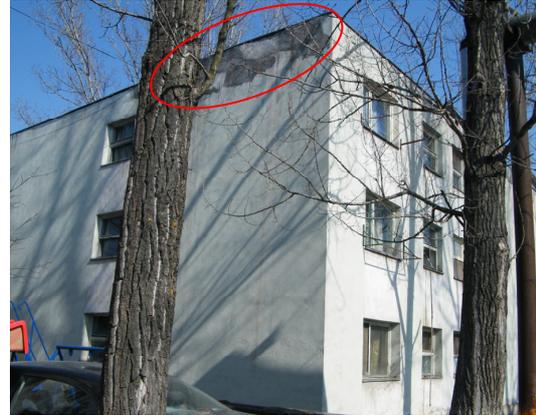
**Fig. 2 - Seeping water in the opaque elements of the building tire at the end of the superior (terrace level - top floor) [12]**

- the terrace above the top floor is equipped with a bituminous waterproofing layer which is intended to prevent the infiltration of rainwater in residential areas. Unfortunately, the existing hydro insulation provides little

protection, as the common areas (stairway) from the top floor show clear evidence of infiltration;  
 - stairwell and wind fang do not feature radiators;  
 - common areas lighting (stairway and hallway access studios) is provided with filament lamps, the artificial lighting level is low.

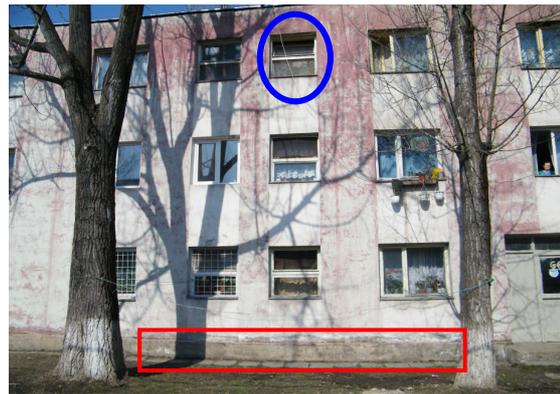
- in the opaque elements outside of the building tire (walls) degradation in patches was observed, more or less pronounced, in the plaster layer outside, in some areas, at the upper end (terrace over the top floor) or at the lower end (floor level) a slight degree of infiltration of water, with the risk of toxic mold (Figures 2 and 3);
- the outside carpenters of windows, in particular that of the common areas, show signs of degradation, chopping wood rot is sometimes achieved with the coating, in some respects, shriveled. Carpentry damage is the result of external climatic factors, and the degree of appropriate leak that allowed water infiltration from weather (Figure 3);

**Fig. 3 - Infiltration of water in the opaque elements of the tire of the building at the end of the lower bound - red border (ground level -building socket) and exterior joinery damaged (blue box) [12]**

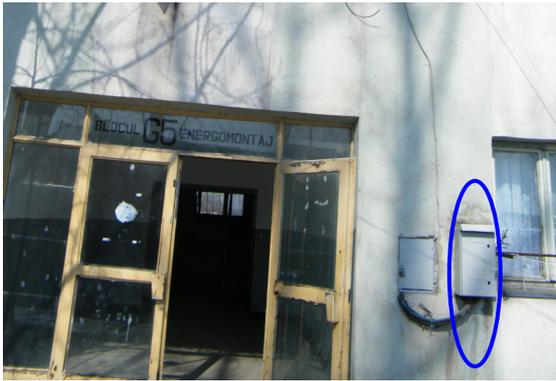
- the external access doors of the block are made from metal with a low degree of thermal insulation, which allow increased infiltration of outside air. The high degree of the outer door glazing favors higher heat transfer between the indoor and outdoor air's wind fang (Figure 4);

- the block has modern metering systems (electronic) for both heat and electricity. Heat metering is only at the block level, while electricity is metered block level (figure 4 - blue box) but for most of the studios there is also

Fig. 4 - The access exterior doors in the block are from metal with large glass surfaces [12]

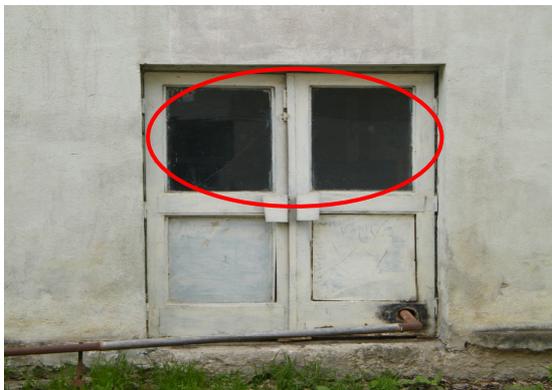
- the outer door of the block of studios, located on the right side (the geographic orientation NE) has windows instead of sheet metal, having a high degree of air permeability of the outside (Figure 5);

Fig. 5 - Doors outer side of the block (the right in the direction of access in the block) presents metal sheet instead of glass - red marked area [12]
